Sutton-Kennerly & Associates, Inc.
530 Hendersonville Road
Asheville, NC 28803-2826

ASHEVILLE CITY HALL
WATER INTRUSION INVESTIGATION
FINAL REPORT

February 16, 2010

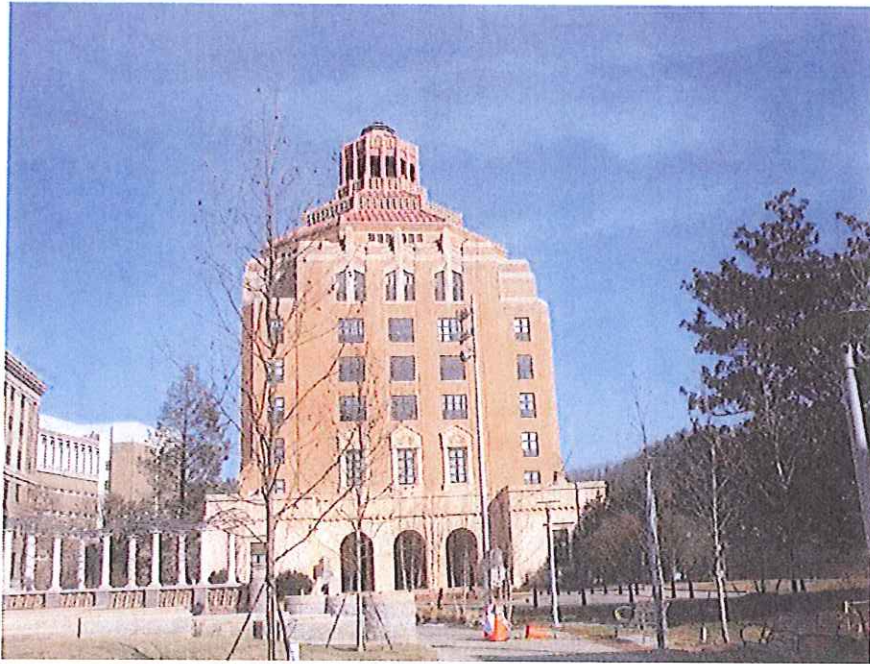
1. A view of the west elevation of the building. The various cladding materials are visible as well as the tiered configuration of the design of the building.

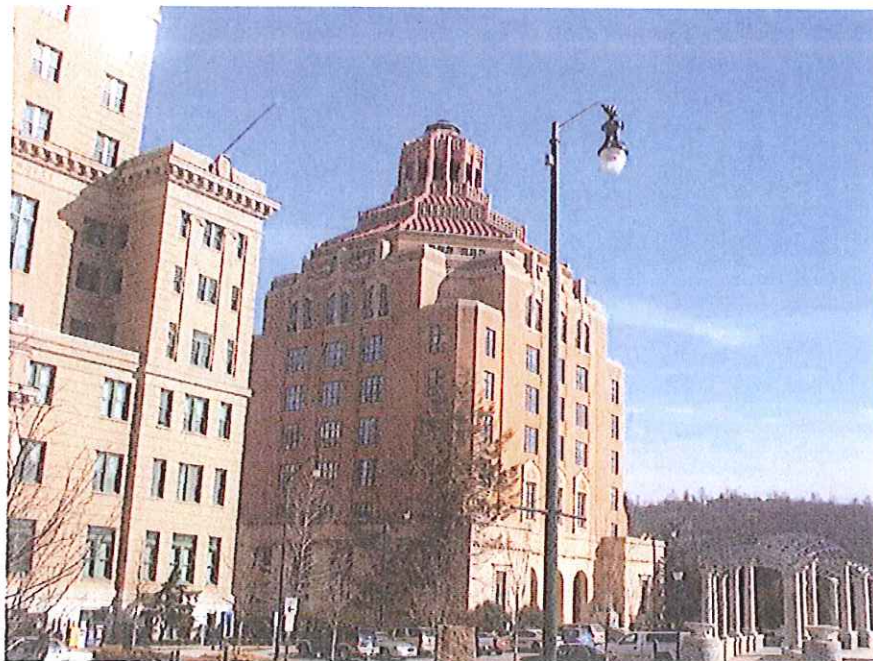
2. A view of the northwest corner of the building showing the north and west elevations. The octagonal roof and the stepped back roof areas are visible in this photo.

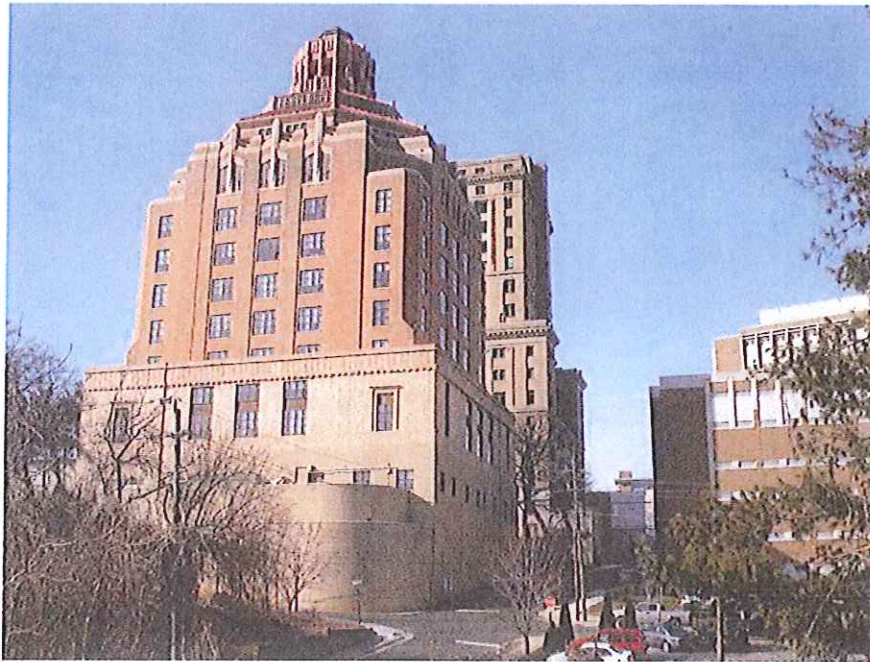
3. A view of the southeast corner of the building. The ramp leading to the basement area is visible in the foreground including the curved retaining wall at the southeast corner of the ramp area.

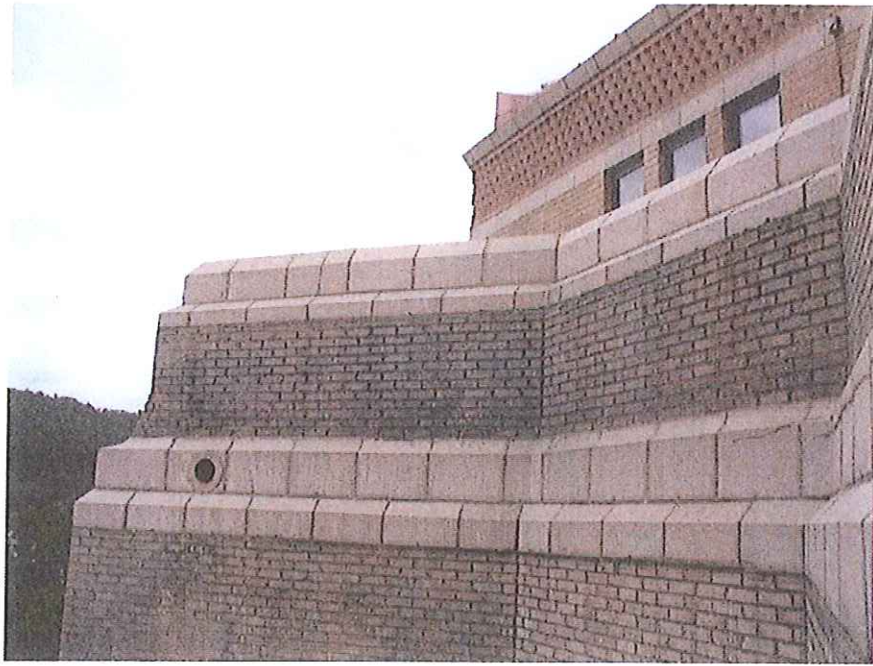
9. A general view of the brick and terra cotta configuration at the eighth floor level.
